Environmental Assessment

New Headquarters Project Monroe County, Indiana

Hoosier Energy REC and USDA Rural Utilities Service

March 2013

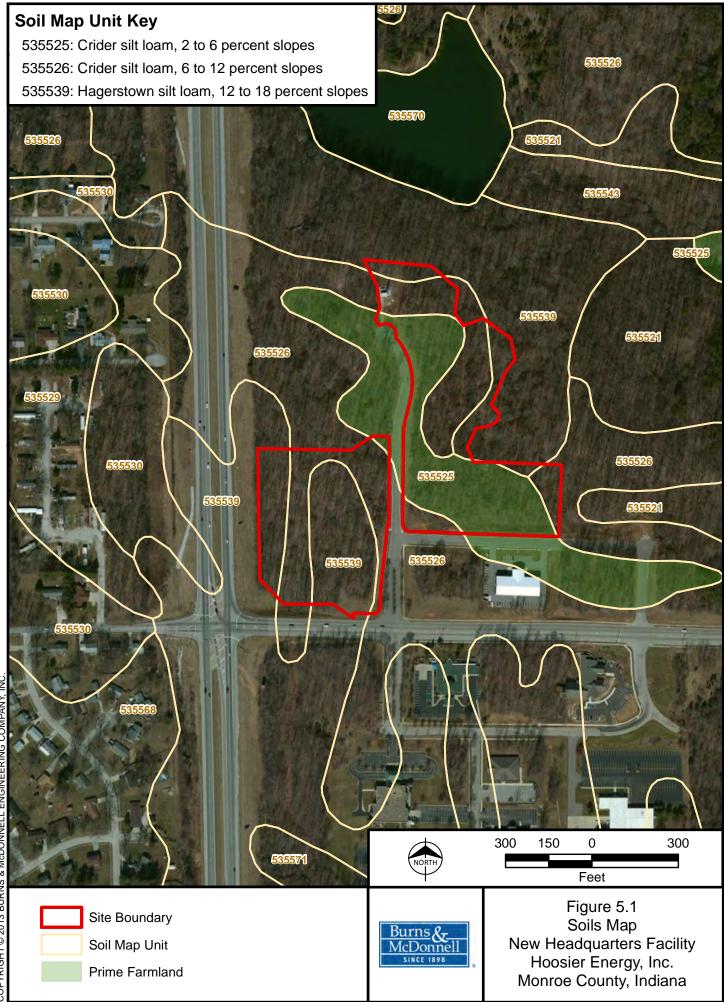
The primary soil type located within the proposed Project site is from the Crider series, with primarily silt loam soils ranging from 2 to 12 percent slope (Figure 5.1). Crider series consists of very deep, well drained, moderately permeable soils on uplands which typically formed in a loess mantle over an underlying residuum of limestone (USDA 2011a). Water capacity of the Crider soils is high with moderate permeability. Runoff from cultivated areas is characterized as medium and the organic matter content of the surface layer is generally considered low (USDA 1981).

Hagerstown silt loam is also found in the southwest portion of the proposed Project site. The Hagerstown series consists of deep and very deep, well drained soils formed in residuum of hard gray limestone; permeability is moderate and typical mean annual precipitation is 30 to 45 inches (USDA 2011b). Hagerstown series are generally found on steeper slopes. Water capacity of the Hagerstown soils is moderate with permeability also considered moderate. Runoff from cultivated areas is characterized as rapid and the organic matter content of the surface layer is generally considered low (USDA 1981).

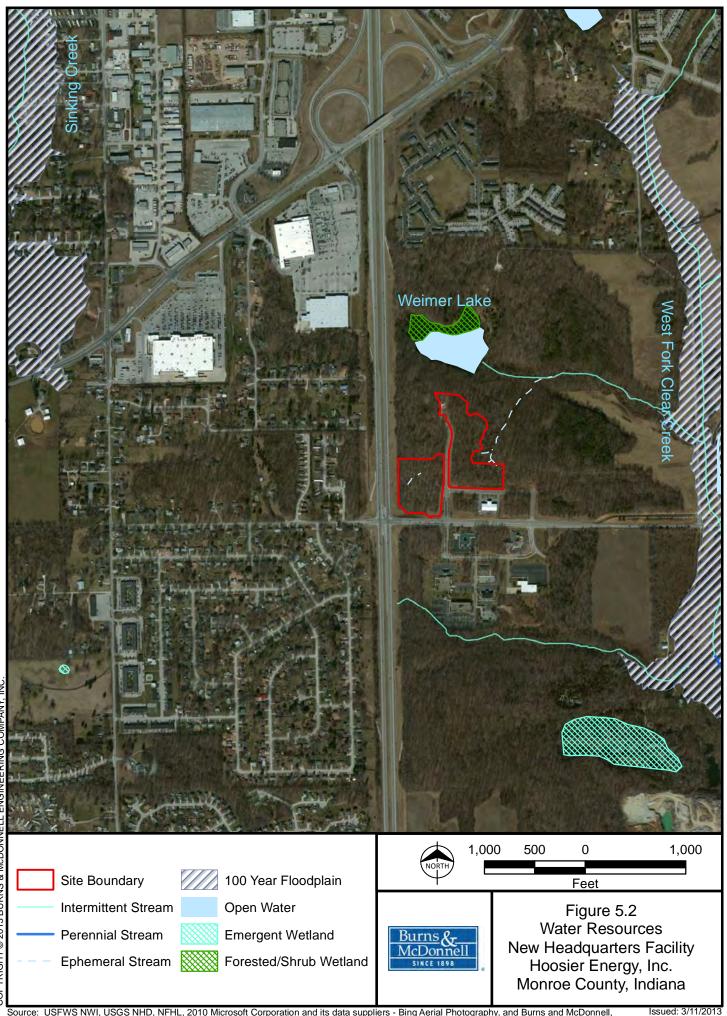
drainage feature originates in the southwestern portion of the proposed Project site and drains to the southwest into the road right-of-way adjacent to SR 37 and Tapp Road. The drainage feature was not observed to have a direct hydrological connection to a "waters of the U.S". The two tributaries were observed to originate within the proposed Project boundary in the eastern portion of the proposed Project site and exhibited an ordinary high water mark. Tributary 1 flows into Tributary 2, which exits the proposed Project site to the east and flows into an unnamed tributary to Clear Creek. Therefore, both tributaries appeared to a have direct hydrological connection to Clear Creek. A summary of the identified tributaries is shown in Figure 5.2.

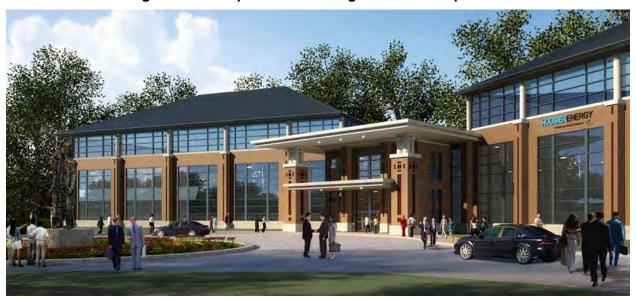
Figure 6.2: Proposed Rendering of New Headquarters

Following construction of the new office complex, the area would change from a mix of commercial operations and undeveloped forestland to a more developed viewshed, particularly when viewed from Tapp Road and SR 37. The proposed building would consist of two, three-story wings with center connecting two-story core. As previously discussed, the north wing would consist of three floors and the south wing with three floors over a basement, which takes advantage of the site topography. The central core of the building would consist of two stories and include the board room, lobby, large conference rooms, executive conference room, and executive offices. The facility would also include above-ground parking for 235 vehicles. A rendering of the proposed structure is included in Figure 6.2.

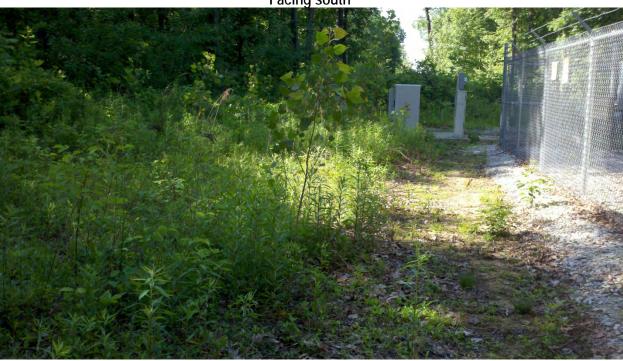
Photo 5. Area adjacent to cellular communications tower Facing south

The area of the SITE subject to this assessment was approximately 16 acres in size and was observed to be entirely forested, with the exception of the areas of Grossman Boulevard, Schmaltz Boulevard, and a cellular communications tower located in the northern portion of the SITE (Figure 5).

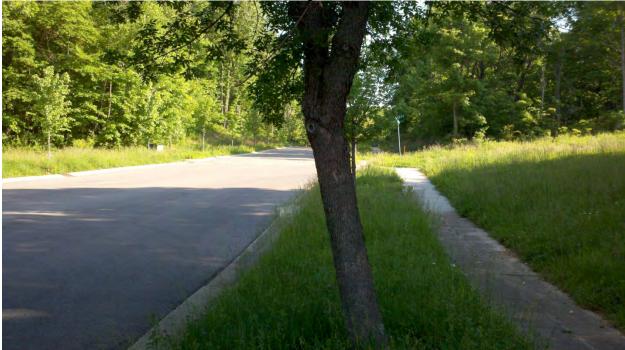
Photo 6. Area adjacent to Grossman Boulevard Facing north

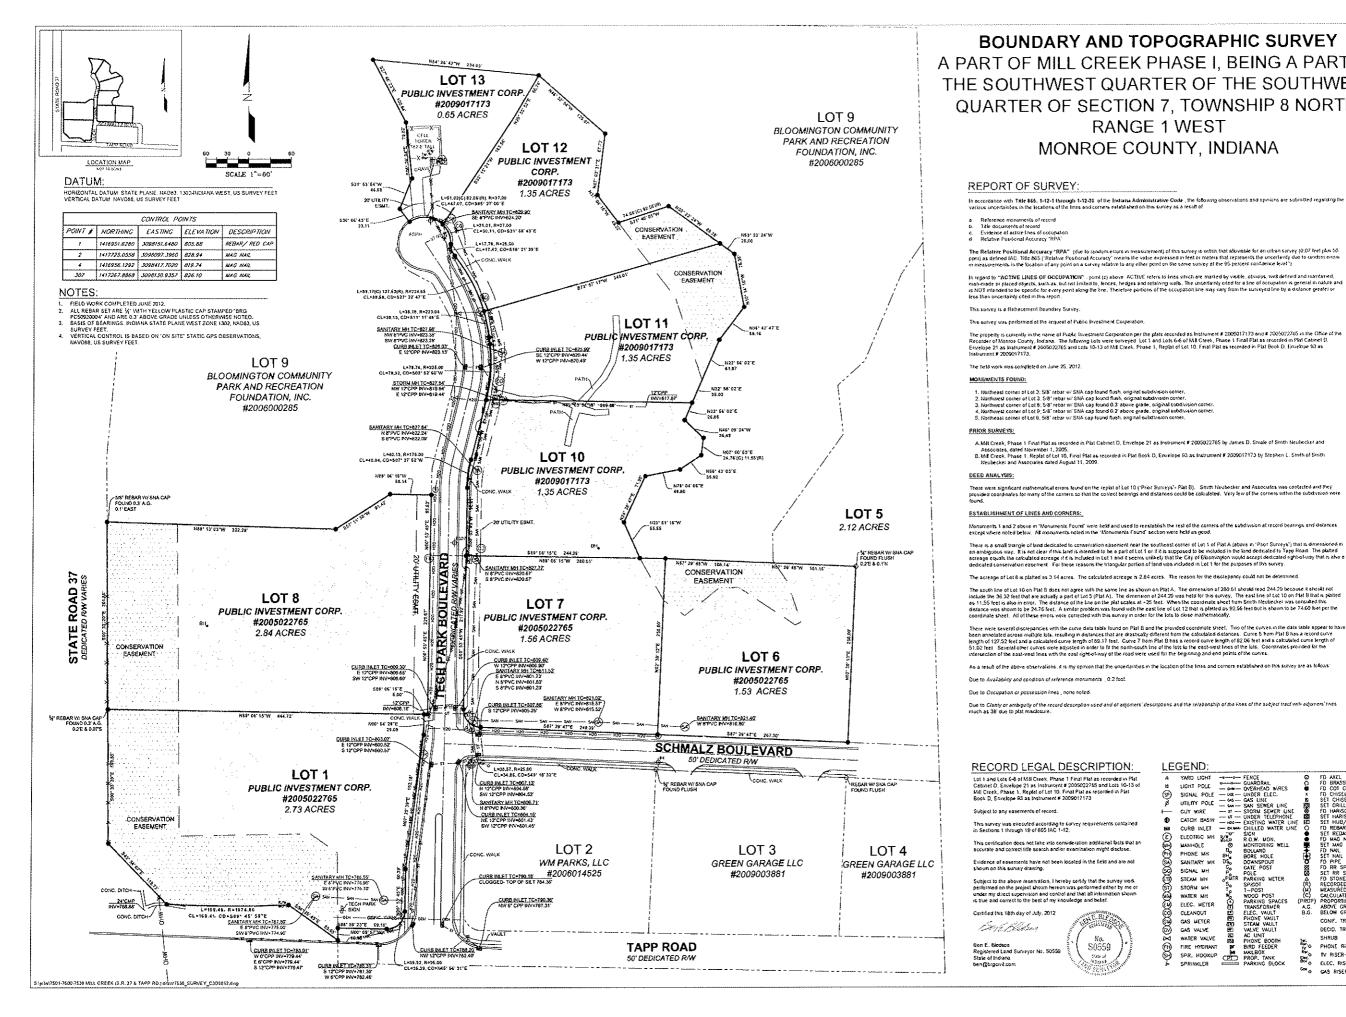
BOUNDARY AND TOPOGRAPHIC SURVEY A PART OF MILL CREEK PHASE I, BEING A PART OF THE SOUTHWEST QUARTER OF THE SOUTHWEST QUARTER OF SECTION 7, TOWNSHIP 8 NORTH, **RANGE 1 WEST** MONROE COUNTY, INDIANA

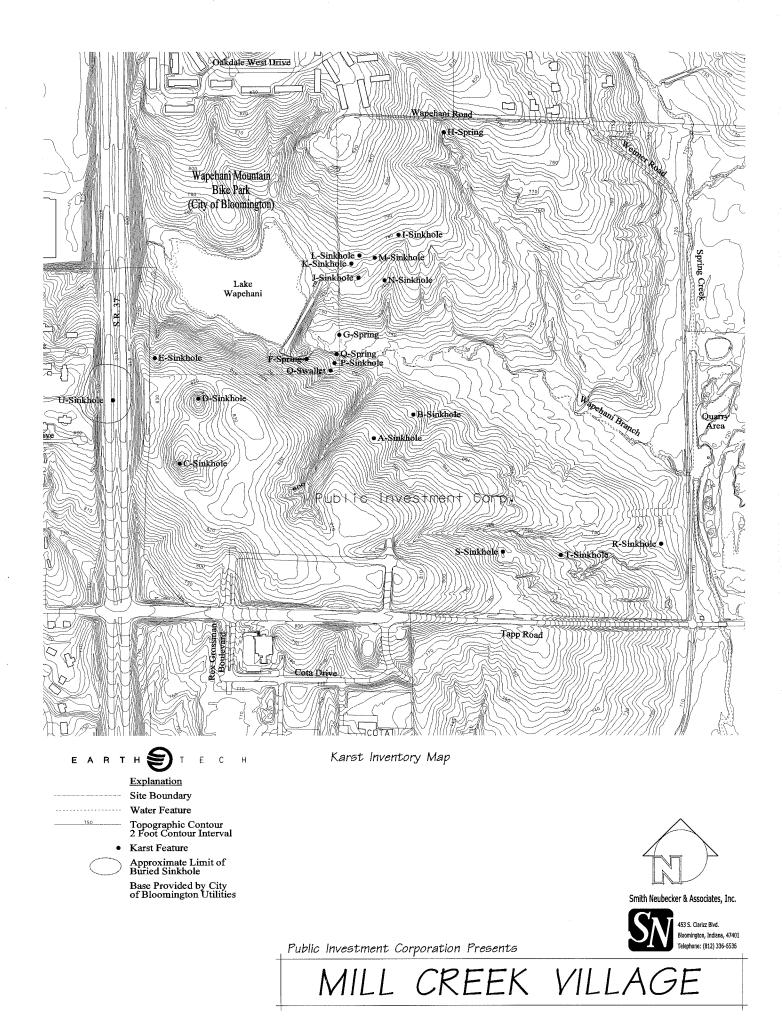
Illustration 9 is a map of the findings provided by John Bassett. His complete report is provided with our application.

The Mill Creek Village plan has subsequently been revised to reflect these findings. Where sinkholes were clustered; they were aggregated within larger open space buffers. Where single karst features were found, buffers of at least twenty-five feet from the last closed contour have been called for. In one case, a karst feature was found in the path of a proposed roadway. That roadway has been removed from the plan.

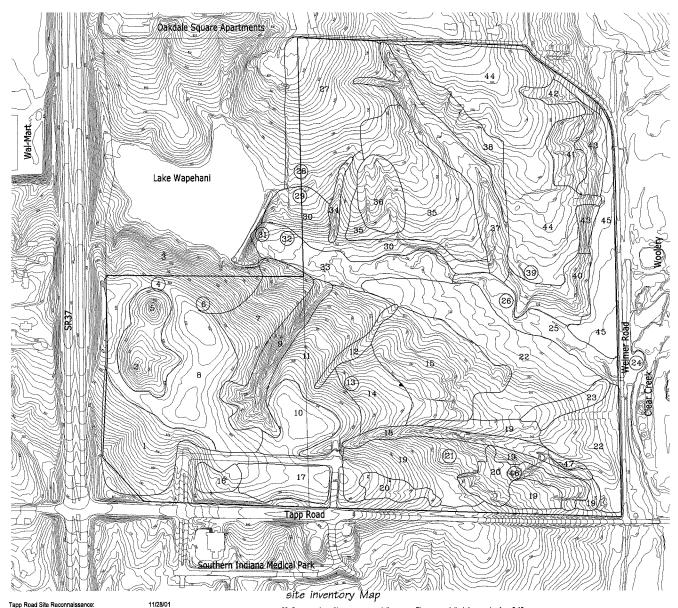
Tapp Road Site Reconnaissance:

Typ road sile recommassance: In 122001 1. Wooded hillside with slopes of around 10-12 percent. Trees are predominantly small diamater with Cherries, Maples, Beech and a few scattered 15°-24° Oaks. The Highway is quite visible and very noisy, especially this time of year. 2. Largest sinkhole in double bottom pair of sinkholes. Did not observe open crevice or water standing. Side slopes ranging from 10-20 percent. Most vegetation is 2°-12° in size with a few scattered larger dia. trees as in area 1. Species are predomi nantly the same mix. 3. Wooded hillside with trees becoming larger in general. Slopes increasing to about 20 percent or more. Lass understory vegetation and a more meture cancpy with larger sizes ranging from 16°-30° dia. View to the lake is good this time of year. 4. Narrow ridge between double sink and hillside to lake. It would be a good path location. The vegetation is small hare, as if aread or larger trail existed at some time in past. 5. Small Sinkhole of the double. Did not observe crevice or standing water. Trees species same mix as larger sink.
